HISTORY

Preserved

THE STONELICK-WILLIAMS CORNER COVERED BRIDGE RESTORATION IS COMPLETE

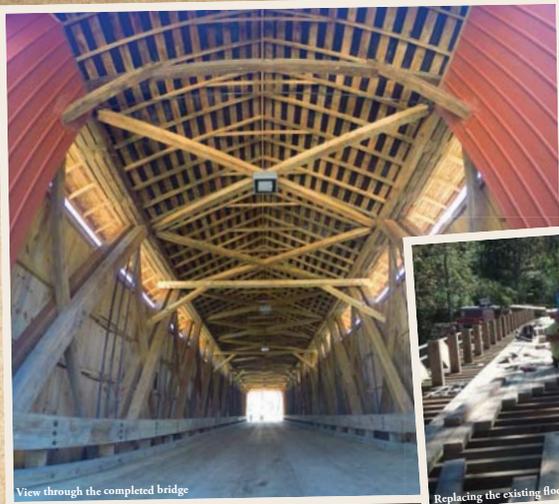
View through the completed bridge

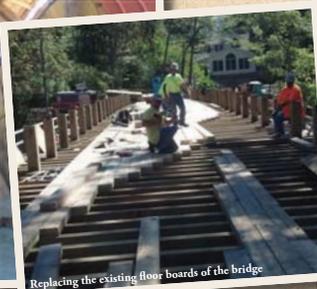
Replacing the existing floor boards of the bridge

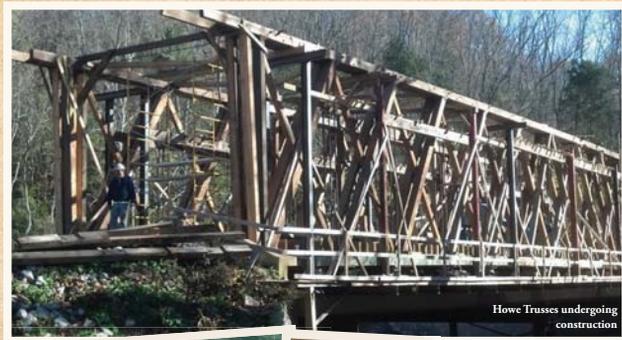
Howe Trusses undergoing construction

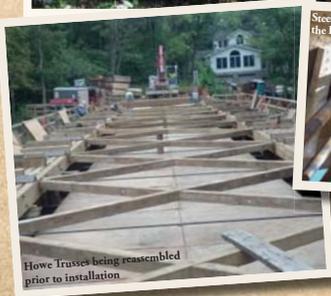
Howe Trusses being reassembled prior to installation

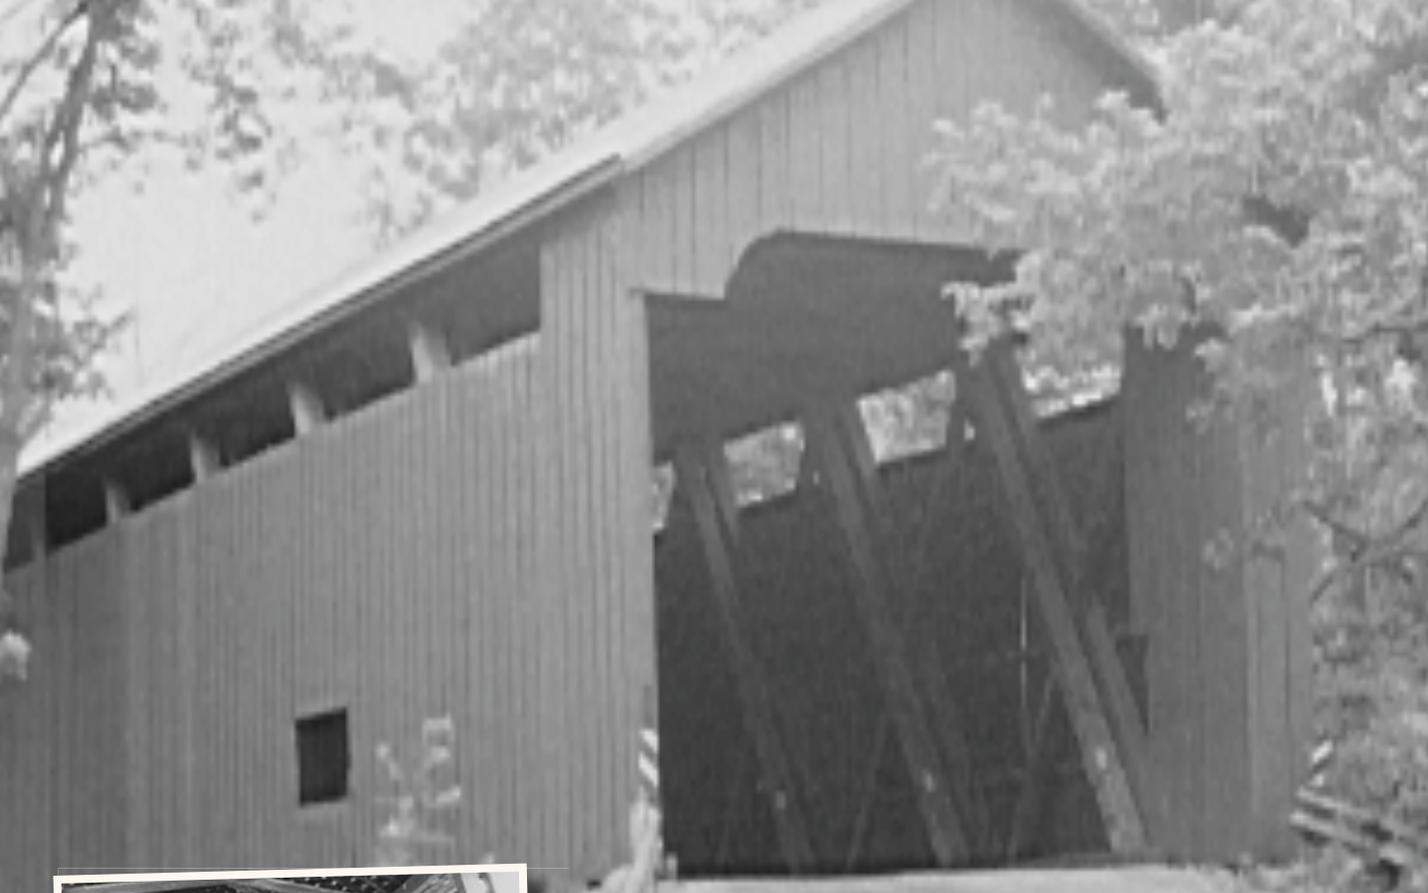
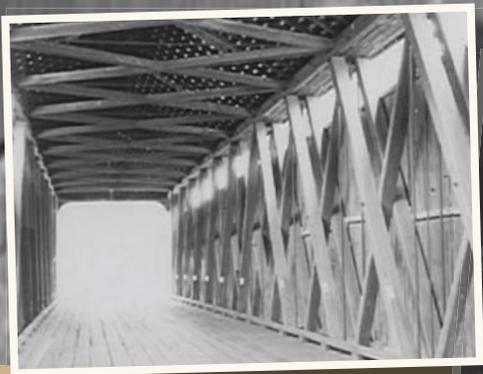
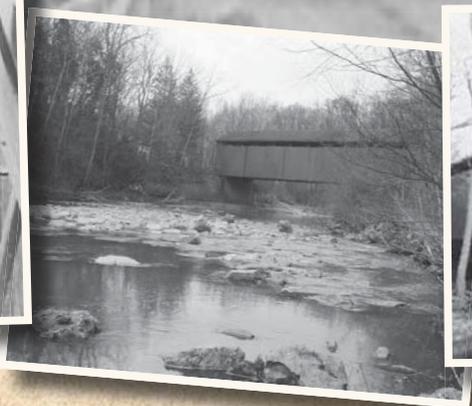
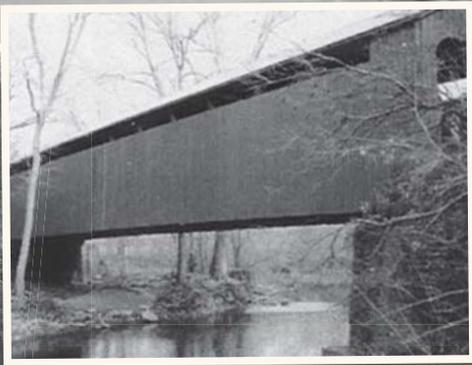
Close-up of truss construction

Steel tension rods support the Howe Truss design

Completed bridge deck

The Stonelick-Williams Corner Covered Bridge is supported by a 12-panel Howe Truss. A relatively rare bridge design, the Howe Truss was patented in 1840, and includes vertical and diagonal pieces that slope up towards the center of the structure. There are about 143 bridges supported by the Howe Truss, or about 15 percent of all covered bridges in the U.S. The Stonelick-Williams Corner Covered Bridge's original Howe Truss configuration was preserved throughout the restoration process.
